# Water Quality Evaluation of Isabella Lake in Preparation for Dam Remediation

Heather Jackson, Alison Plant, and John Baum

U.S. Army Corps of Engineers Sacramento District, Environmental Engineering Branch, 1325 J Street, Sacramento, California 95814

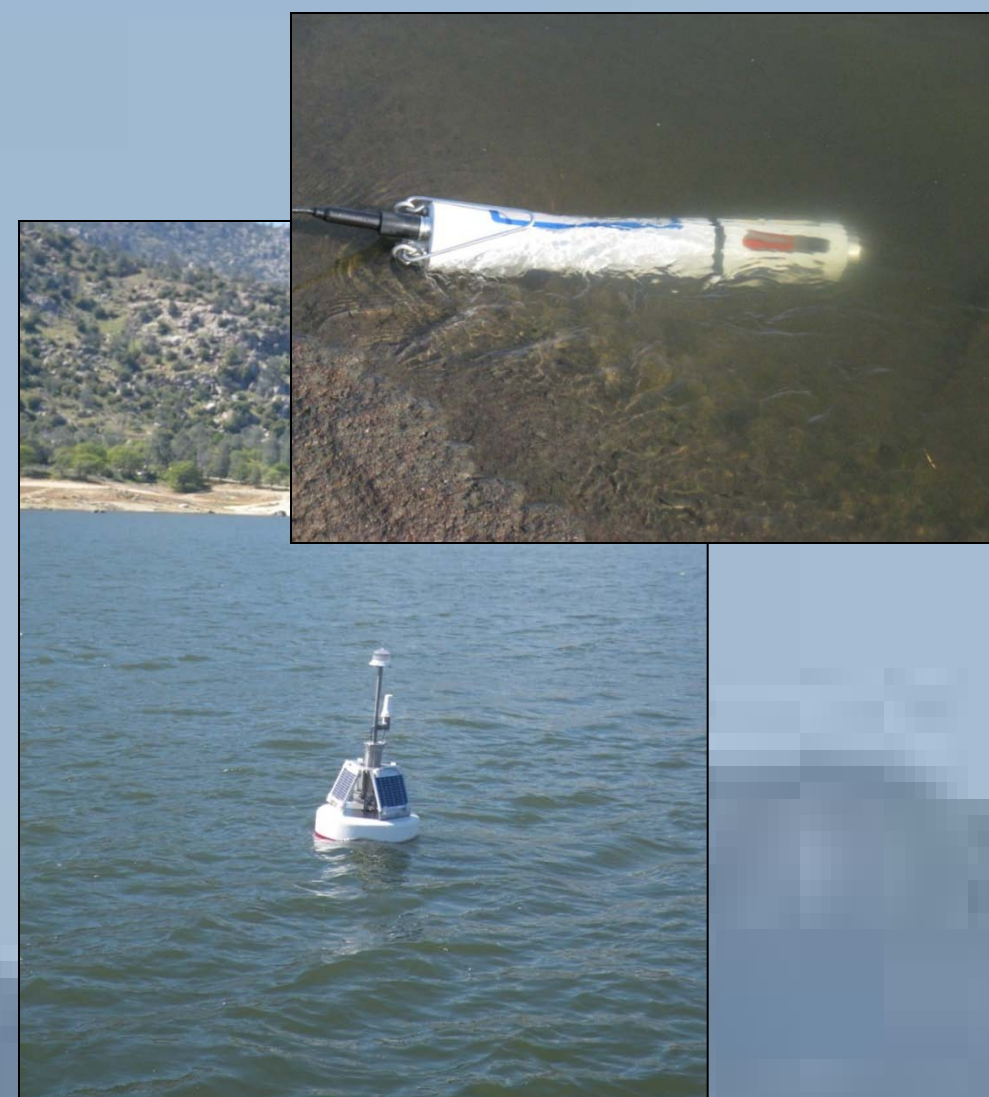
FIGURE 2: Multi-sensor sonde (top) and monitoring buoy at the Main Dam (bottom)

A field team from the USACE Sacramento District visits the reservoir monthly to monitor a wide range of parameters using a Hydrolab™ Multiprobe sonde, as shown in Figure 2. Water quality data is obtained from the Kern River's north and south fork inlets and both the Main and Auxiliary Dam outlets. Water quality profiles are also taken upstream of both dams at the presumed deepest locations; data is collected at 1-meter intervals to examine the reservoir's strata. Figure 11 shows the monitoring locations where data is collected during each visit. The collected data includes water depth, temperature, pH, conductivity (salinity), dissolved oxygen (DO), and turbidity. Data is also collected on an hourly basis in the top 1 meter of the reservoir by a sonde housed in a buoy near the Main Dam (Figure 2). The buoy was installed in April 2011. This time resolution will be more relevant to expected conditions that need to be analyzed during any remediation activities.

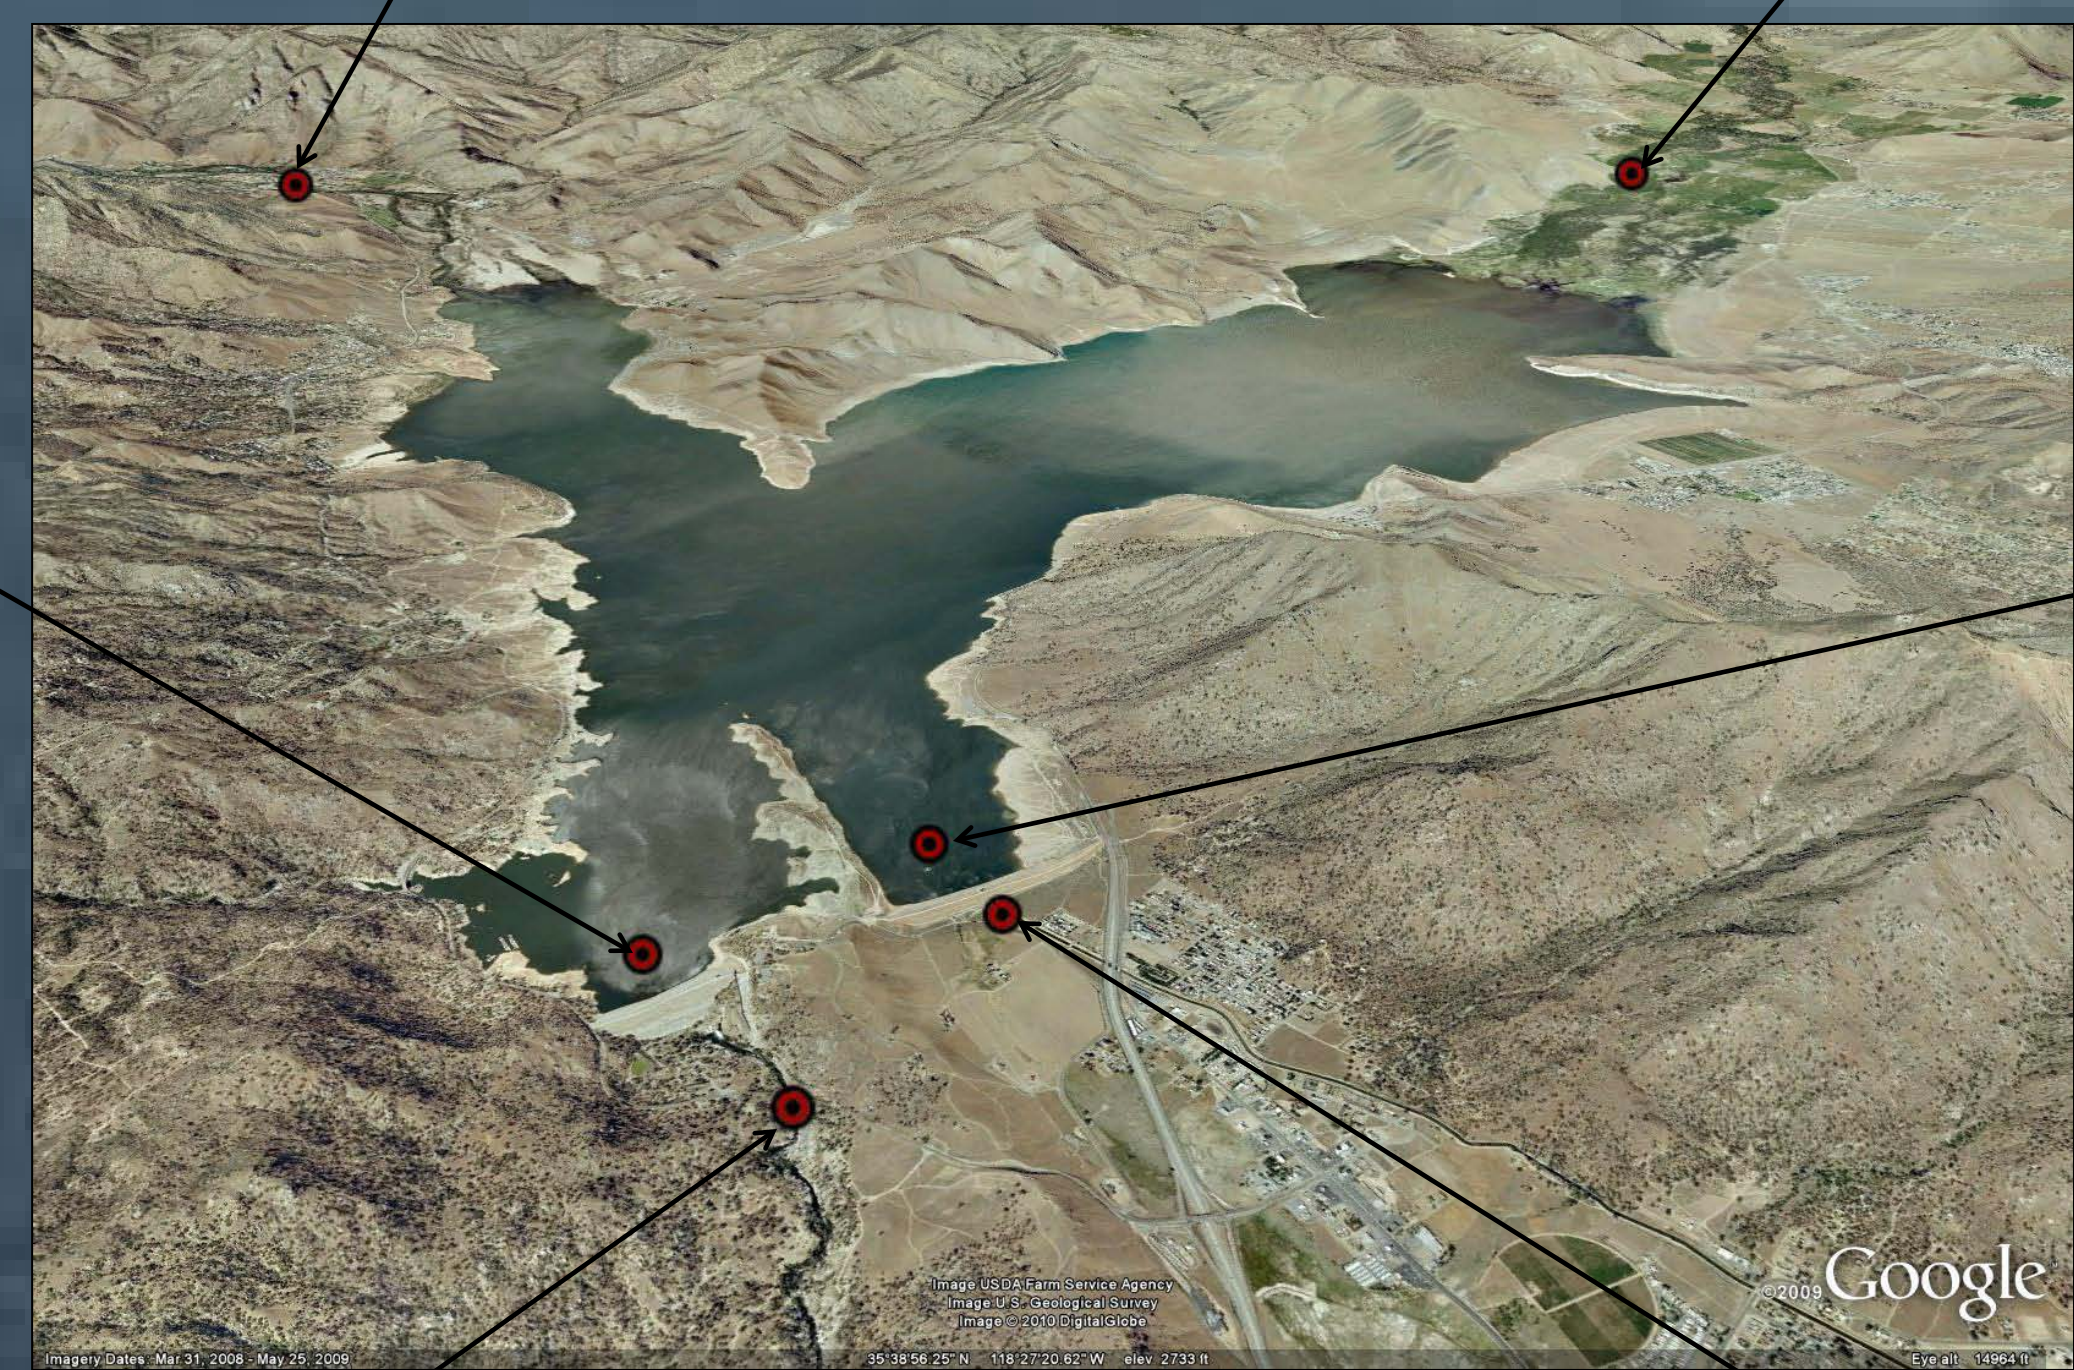
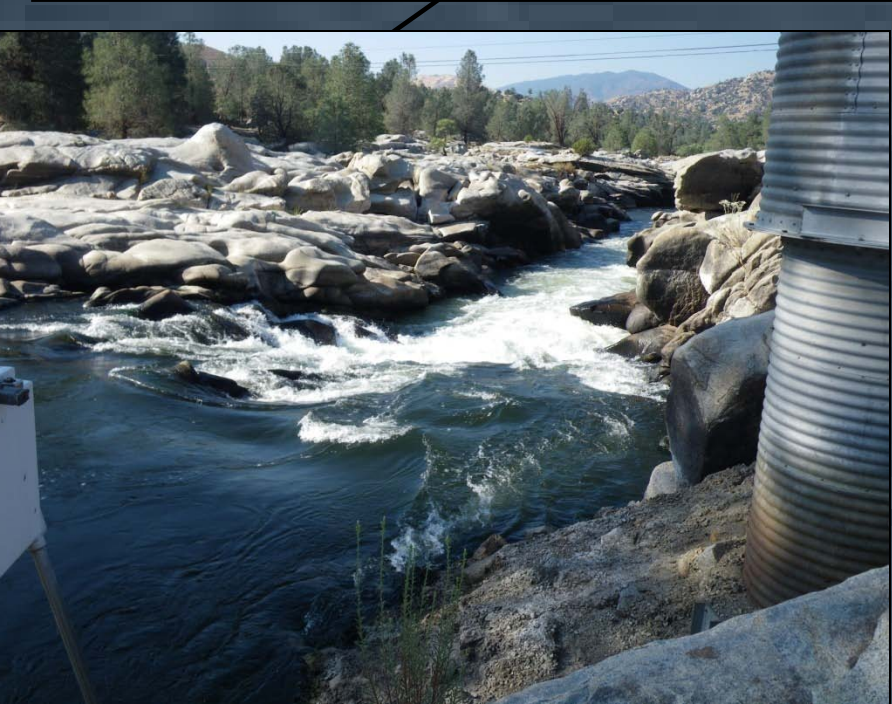
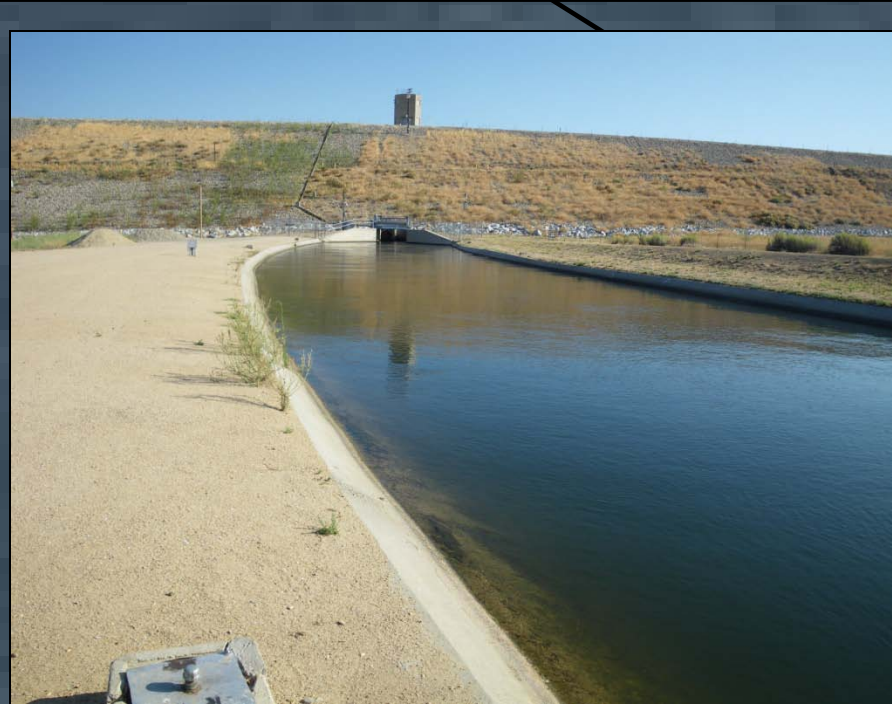
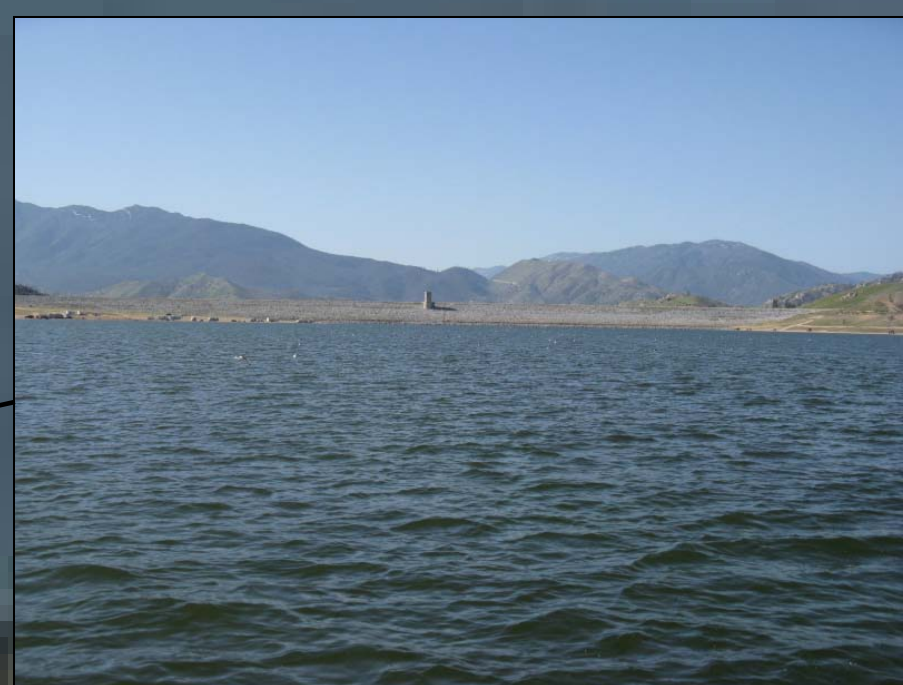
FIGURE 11: Current Monitoring Locations

Main Dam Outflow

Auxiliary Dam Outflow

Auxiliary Dam Profile Location
